TECHNICAL DATA SHEET

ISSUED BY TIMBER OUEENSLAND

TIMBER AND STAINS (TANNIN, MOULDS, IRON ETC)

RECOMMENDED PRACTICE // APRIL 2021

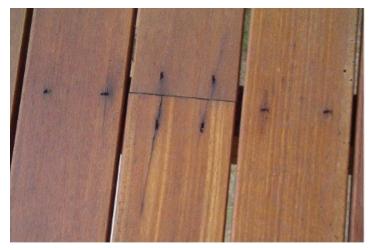
Photograph 3 - Iron staining due to ungalvanized nails (also nails are not appropriate type)

To prevent iron staining occurring in timber it is necessary either to use seasoned timber and to keep it dry, or to use hot dip galvanized fasteners and keep iron based metals away from the timber. Coating the timber with a water repellent product may minimise the incidence of iron staining.

If iron staining is the problem, household bleach could be tried before resorting to oxalic acid.
